Wood Destroying Insect Inspection Report

Date of Inspection
01/05/2021

Structure(s) Inspected
Main House

312 Wye Harbor Drive
Queenstown MD 21658

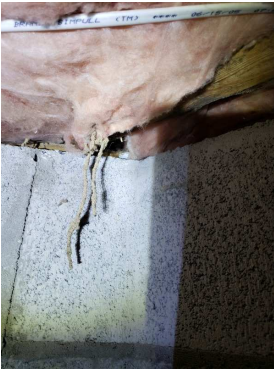
Evidence of termite activity was observed in the crawlspace at the front left corner behind the garage.

Termite shelter tubes in the crawlspace

Recommend treatment for the control of termites at this property.

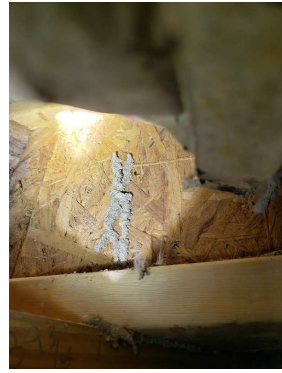
Termite shelter tubes in the crawlspace
